AIRCRAFT ACCIDENT REPORT

AMERICAN AIRLINES, INC., LOCKHEED ELECTRA, N 6101A,
IN THE EAST RIVER, LA GUARDIA AIRPORT, NEW YORK,
FEBRUARY 3, 1959

SYNOPSIS

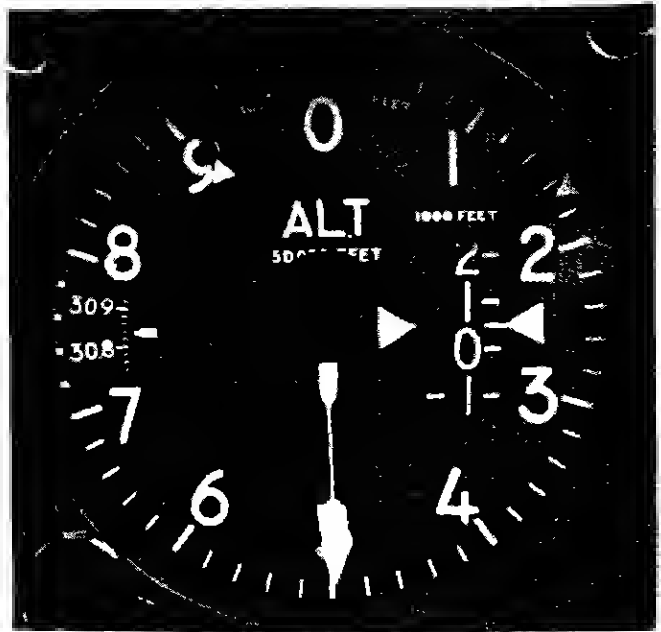
PRECISION DRUM TYPE ALTIMETER

Internal inspection of the altimeters revealed considerable corrosion within each of the instruments. A broken link pin was found in the captain's altimeter and a rocking shaft pivot was found broken in the first officer's altimeter. The corrosion was removed to permit a detailed inspection of the moving parts. The broken components were replaced, after which both instruments were checked for mechanical freedom and were found to operate without significant restriction over a range of minus 1,000 feet to 12,000 feet.

Because of the novel presentation components of the altimeter, serious consideration has been given the possibility that the pilot misread the altitude indication and thereby permitted or caused the aircraft to deviate vertically from the desired flight path. While some incidents have been reported in which a pilot had misread the 1,000-foot scale on the small drum, no such error could conceivably be involved here. The altitude presentation below 1,000 feet is accomplished by a pointer the indications and appearance of which are, for all practical purposes, identical to those used by the crew in other aircraft types and the interpretation of which calls for no new or different evaluations on the part of the pilot.

The reversed sensing of the altimeter setting numerals has already been mentioned. While an erroneous setting might result from this condition, the possible order of error would be very small indeed. Unlike the primary instrument flight reference which is frequently "generalized" by approximate positions of pointers or indicators, the altimeter setting scale must be read in order to permit any substantial correction to be made. Furthermore, the altimeter setting positions which were found in the altimeters installed in this airplane are very reliable indications of the settings existing at the time of the accident. The

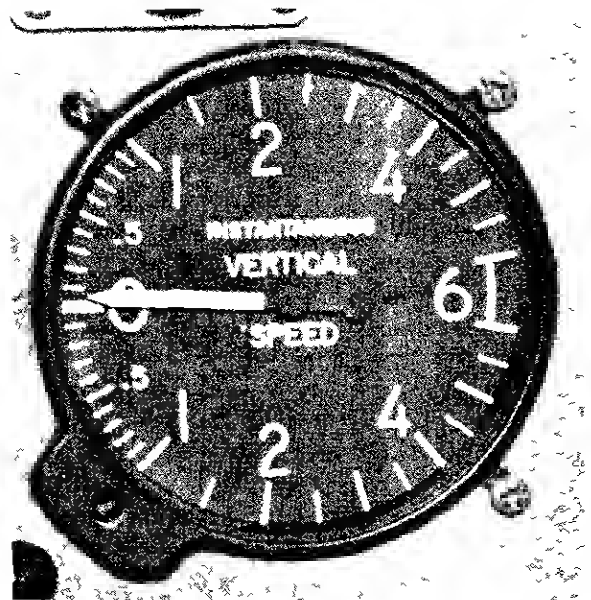
INSTANTANEOUS VERTICAL
SPEED INDICATOR

The two instantaneous vertical speed indicator instrument casings were still attached to their respective panels and relatively intact, but the instrument mechanisms were missing and were not recovered. Only one instrument face was recovered.

The Board believes that the destruction of the two instantaneous vertical speed indicator internal mechanisms was caused by impact and submersion of the instrument panels in approximately 20 feet of water.
